DRR Team mission report Minas Gerais state, Brazil

Mission dates: 13-19 October & 25-29 November, 2019

Document title	DRR Team Mission Report Minas Gerais state, Brazil
Status	
Date	December 2019
Project name	
Reference	DRR219BR01/06

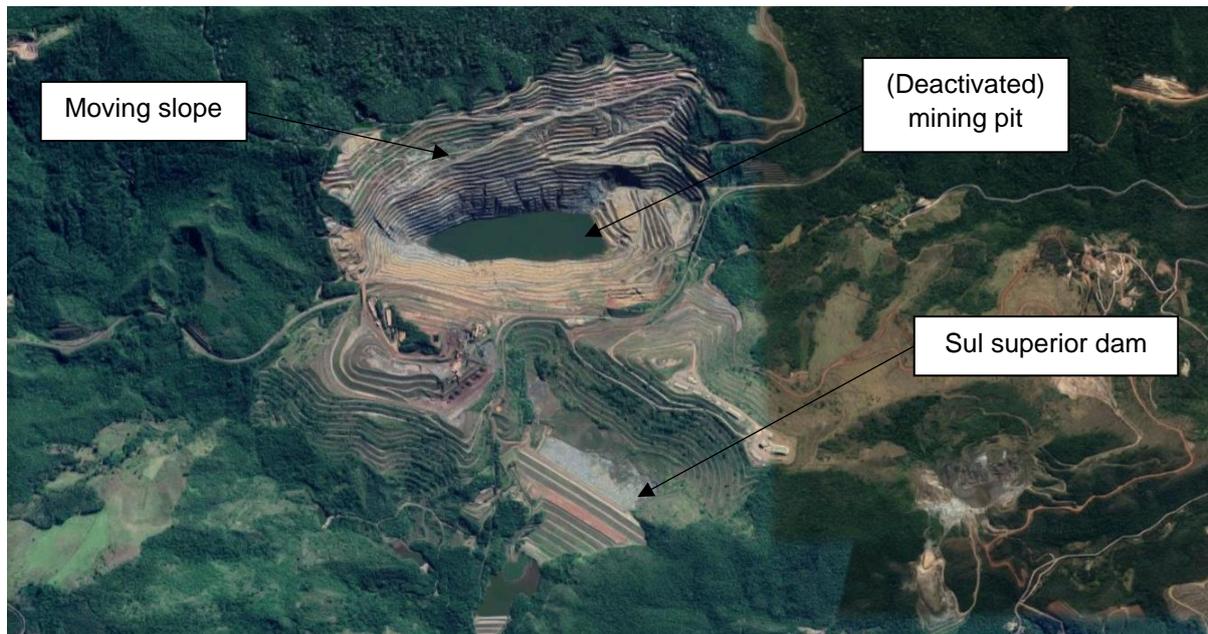
Sul Superior is an upstream dam located in the Gongo Soco mine, in Barão de Cocais (see Figure 1). Previously a gold mine, it has until recently been used for iron ore extraction. Vale took over the mine operations in 2001. The initial project and design information of the Sul Superior dam was not available, but Vale carried out a site investigation program after the take over and used these results to design the subsequent dam raises. Vale carried out 4 of the 8 dam raises; each dike is 10m high (total 80m) and made from compacted itabirite (with low iron content). The total volume (dam plus tailings) is 6.8 million m³.

Figure 1. Sul superior dam

The design of the dam did not include a drainage system. Now no seepage is observed in the dam.

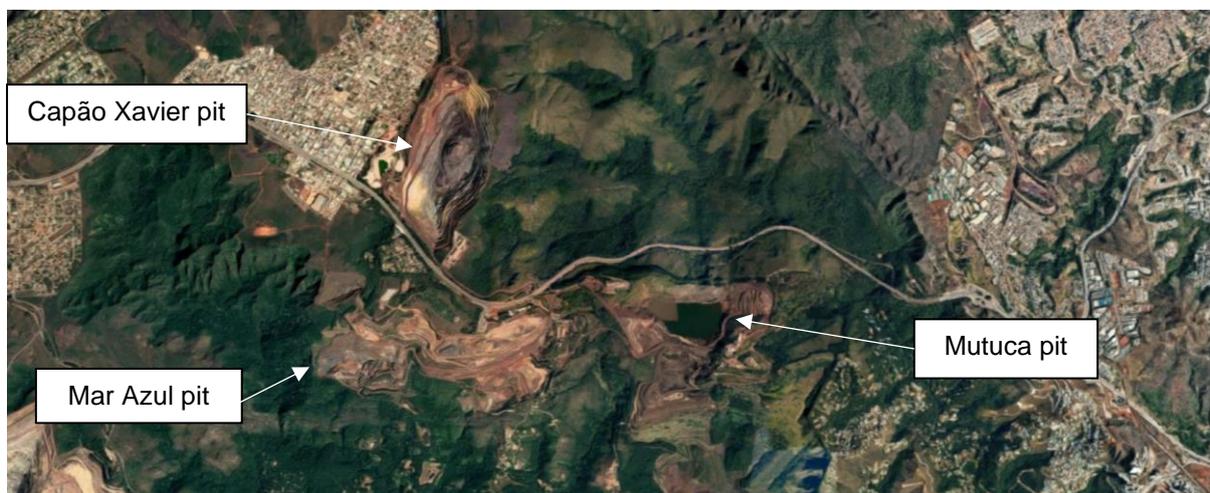
B3/B4 is an upstream dam located in the Capão Xavier mine complex (see Figure 2). The main elements of this mine complex are:

1. The Capão Xavier mine, the only one still active in the complex;
2. The Mutuca mine, deactivated for many years, now used for in-pit disposal;
3. The Mar Azul mine, located close to the B3/B4 dam. Activity has stopped in this mine because it may cause a trigger for the collapse of the B3/B4 dam (due to traffic or blasting).

Figure 2. Capão Xavier mine complex

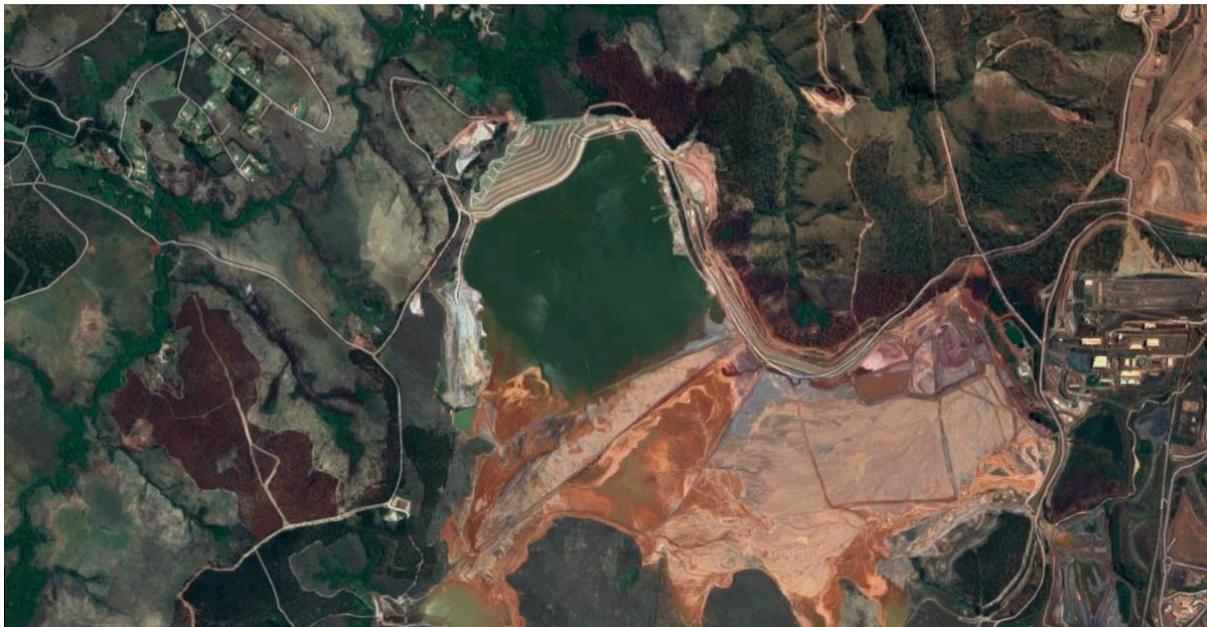
Maravilhas II (see Figure 3) is an upstream dam located in the Vargem Grande mine complex. This complex comprises 6 mines, 15 dams, 3 cargo terminals, ca. 2800 employees and produces 43 million tons of iron ore per year. The entire complex has been deactivated since February 2019.

Figure 3. Maravilhas II dam

Within this complex, the Vargem Grande dam is in emergency level 2 (due to risk of liquefaction) and the Maravilhas II dam is emergency level 1. Vale has now cleared the drainage system of the Vargem Grande dam, which results in an increase in the safety factor and in a future decrease in emergency level from 2 to 1.

On the left shoulder, seepage has been reported. This is attributed to the poor behaviour of the drainage system and seepage through the underlying fractured quartzite rocks..

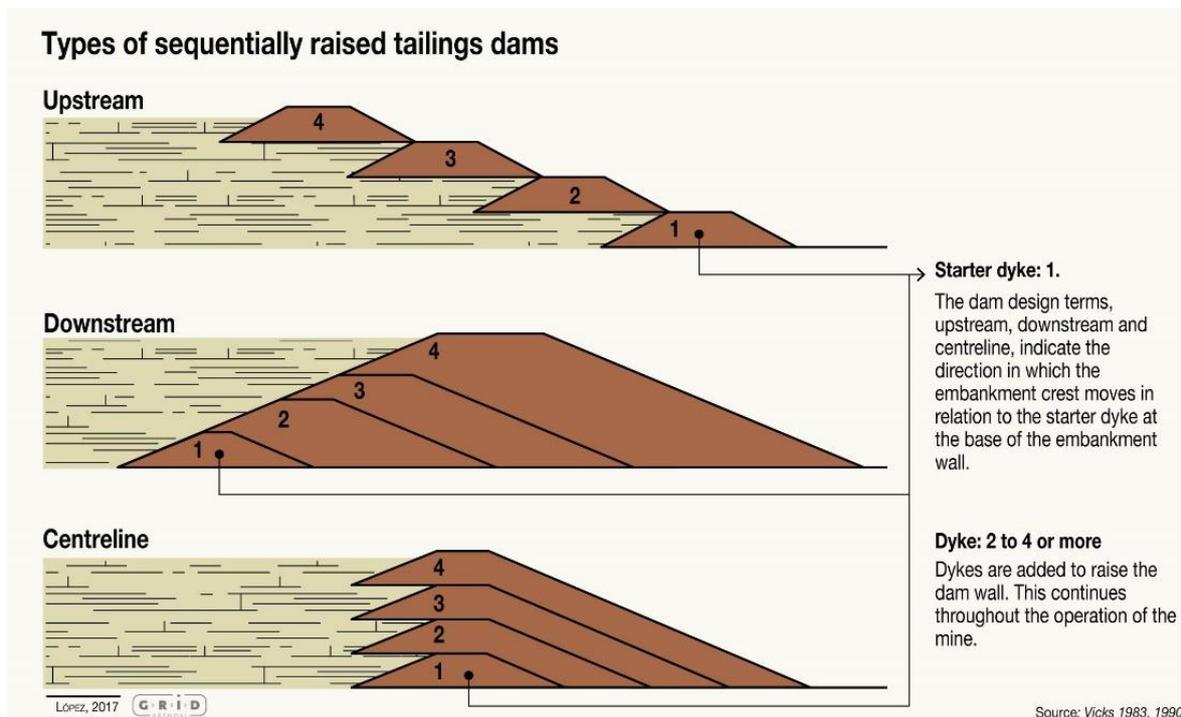
Tailing dams have in the past been constructed in different ways, but the most flexible and therefore economical way is the upstream method. The upstream method means that a starter dike is constructed first, usually within a valley, thus the valley walls constrain the tailings from the sides. The tailing material is then placed hydraulically (with water) in the area behind the starter dike (pond). Once the pond is filled a new dike is constructed, partly over the existing tailing material and partly over the starter dike. The TSF can be subsequently filled in several stages using the same method, whereby significant heights and volumes can be reached (see Figure 4.). The upstream method is inherently the most instable method of construction, since the dam is resting partly on tailing material, which is weak material, usually saturated and prone to static liquefaction.

Figure 4. The three type of tailing dam construction sequences generally encountered (From: www.grida.no)

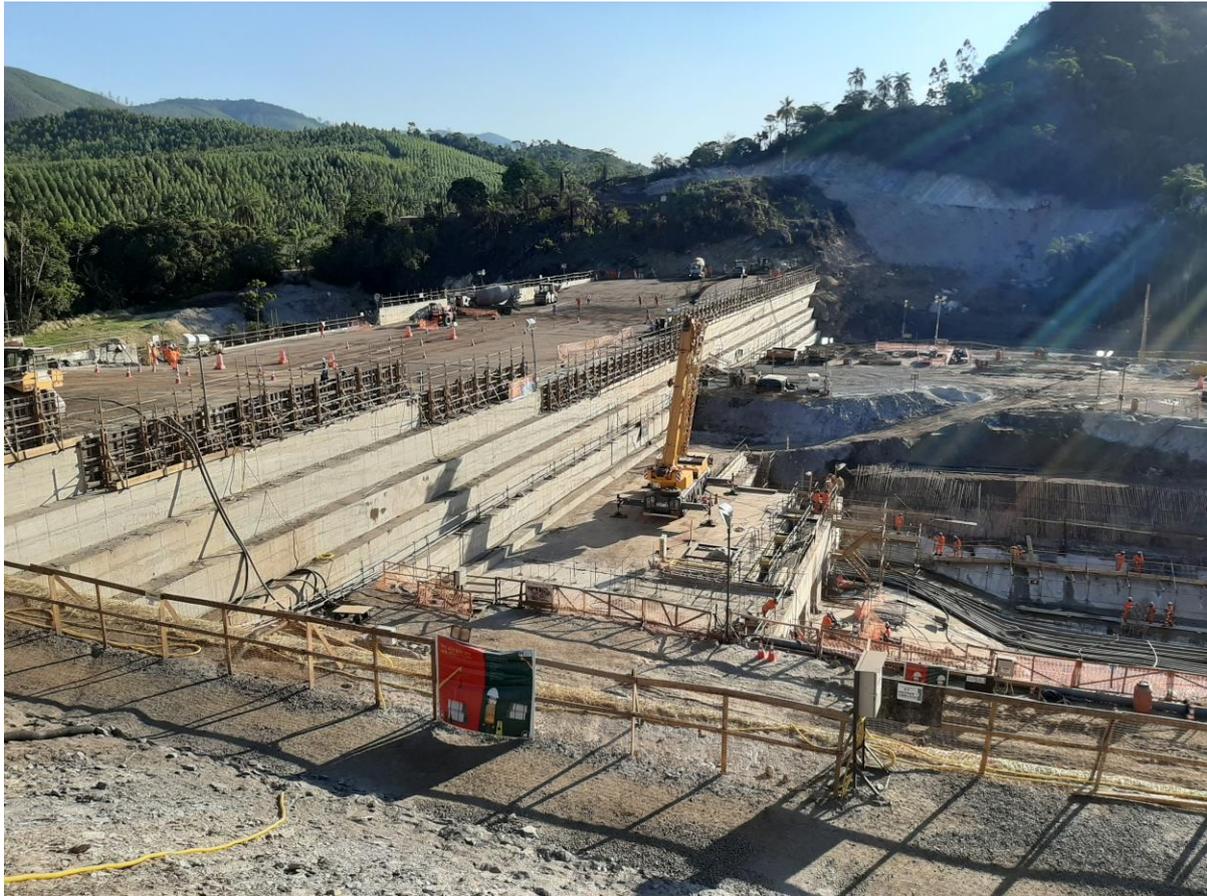
Figure 5. Containment dam downstream of Sul Superior dam

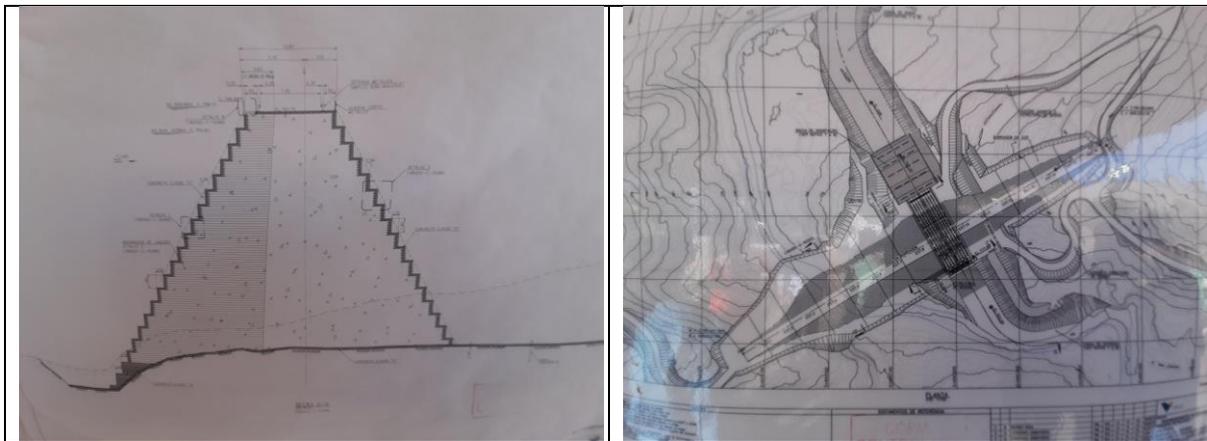
Figure 6. Containment dam downstream of the Sul Superior dam

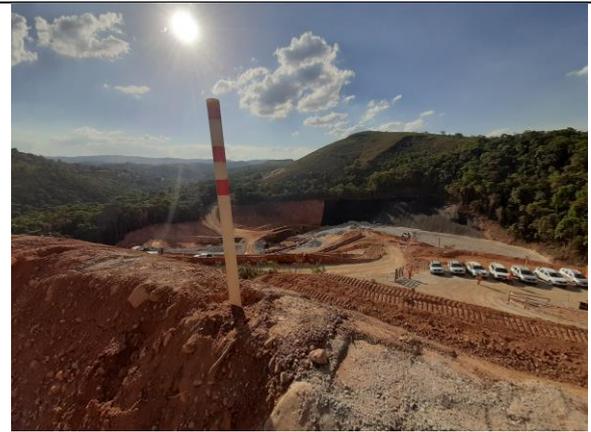
Figure 8. Rockfill dam downstream of tailing dam B3/B4
