ENVIRONMENTAL IMPACT ASSESSMENT (EIA)

THE POST-TSUNAMI RECONSTRUCTION OF VILUFUSHI ISLAND IN THAA ATOLL

**PROJECT SUMMARY
OCTOBER 2005**

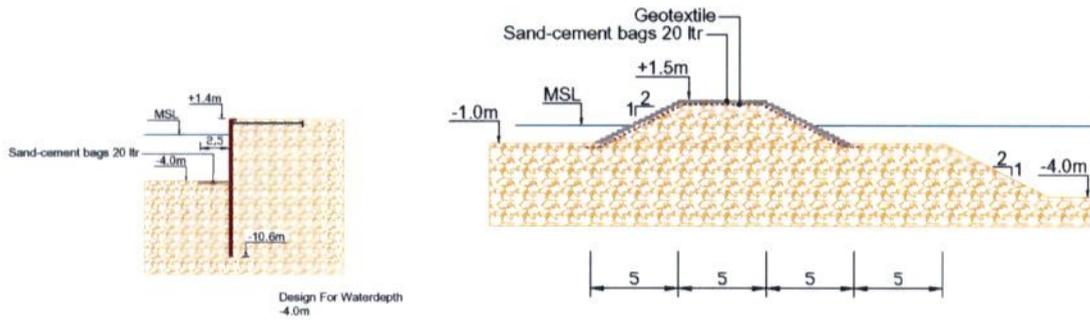
Figure 6: Harbour details (cross section of quay wall and breakwater)
 Figure 7 shows the proposed land-use plan for the new, enlarged (60 hectare) and safe Vilufushi island.
